REHABILITATION ACTIVITIES IN THANH
HOA PROVINCE FOLLOWING TYPHOON IRVING

Project No: VIE/89/035.

REPORT OF MISSION TO THANH HOA

M. Mitchell.

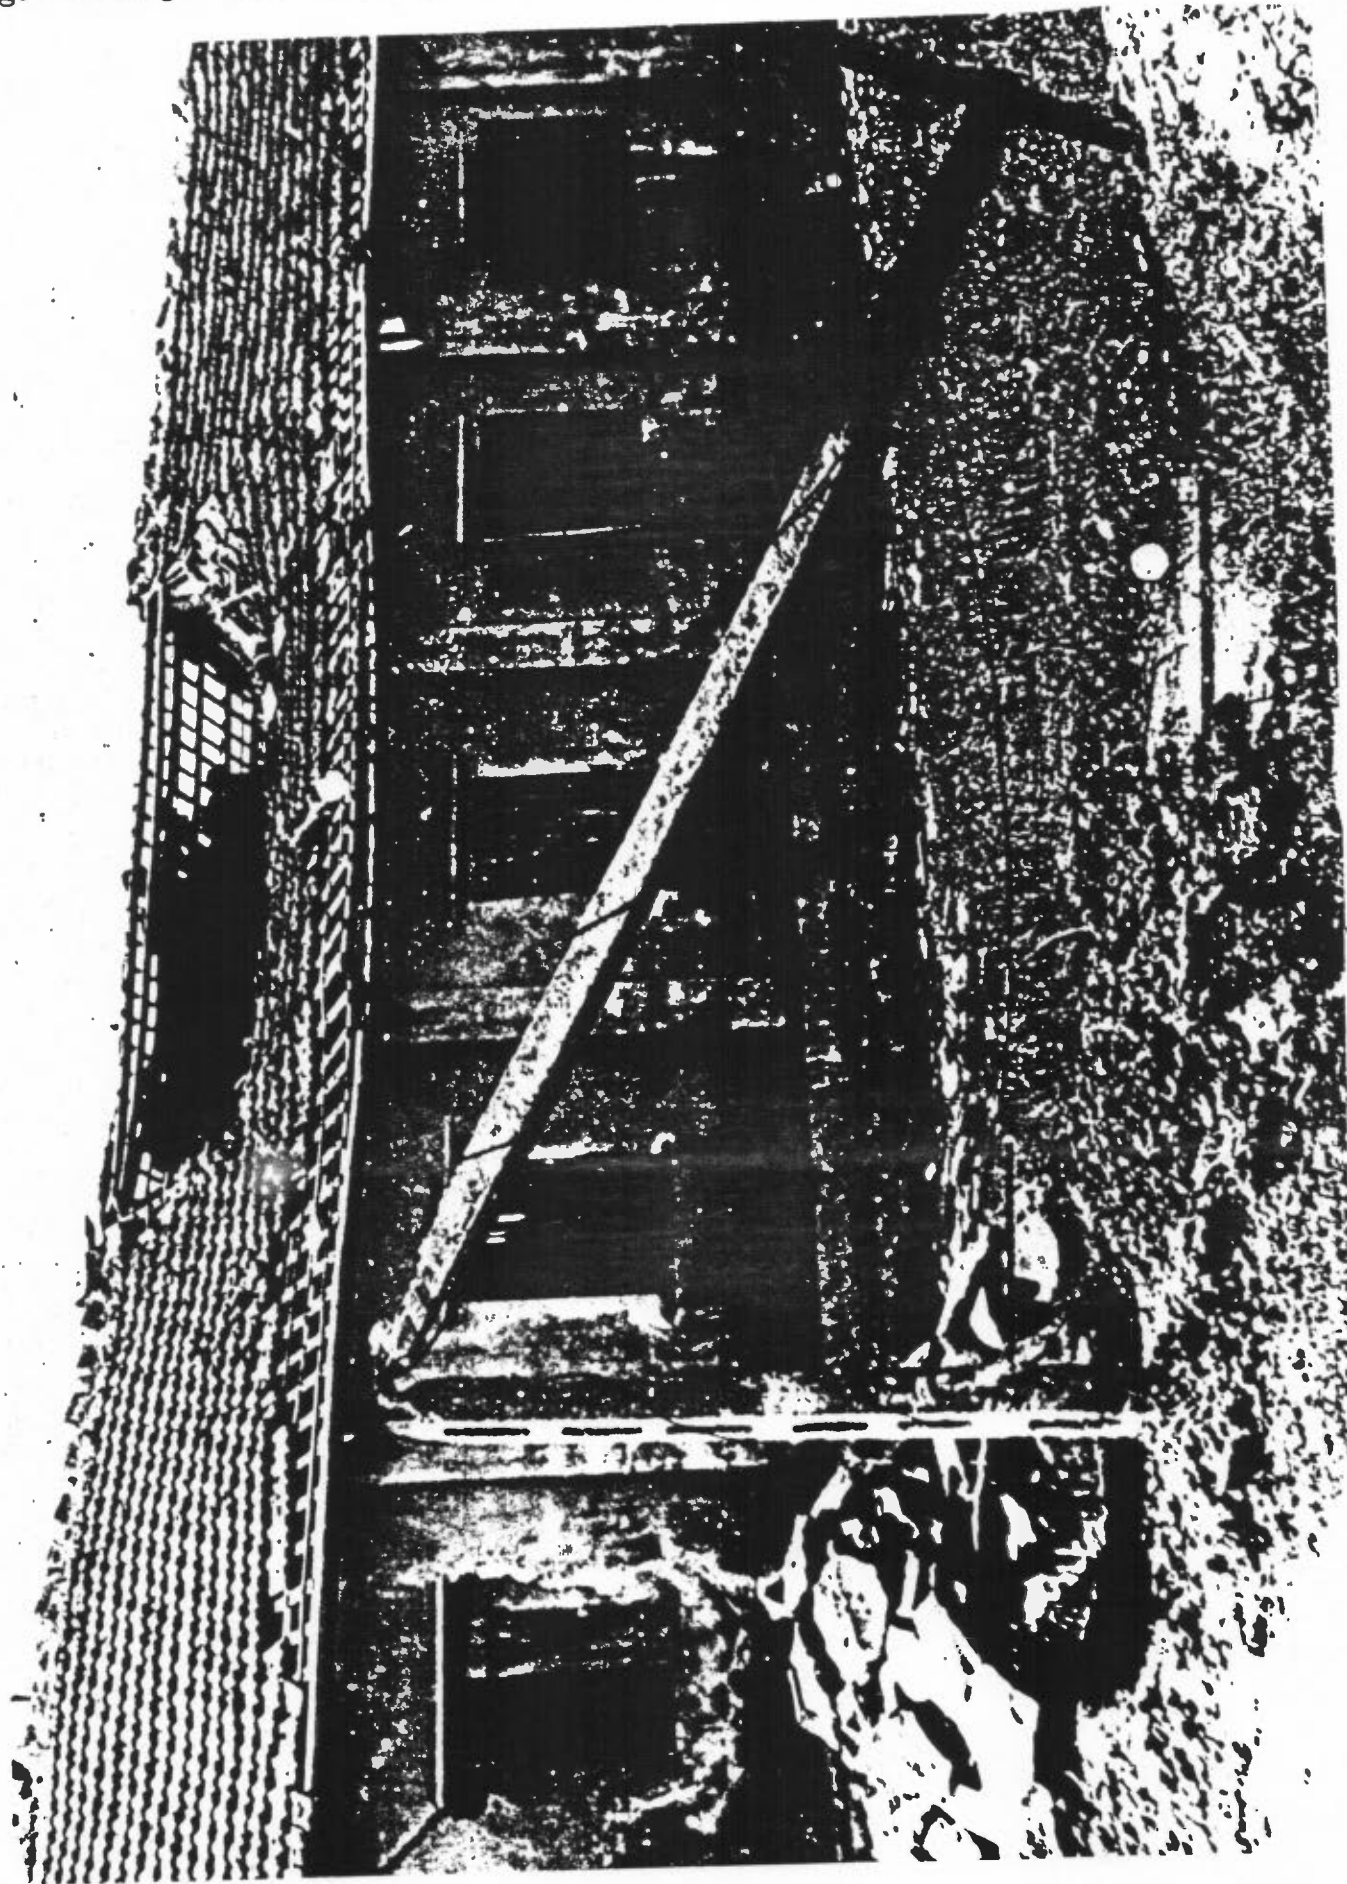
Fig. 14 Damaged ward at Quang Xuong Hospital.

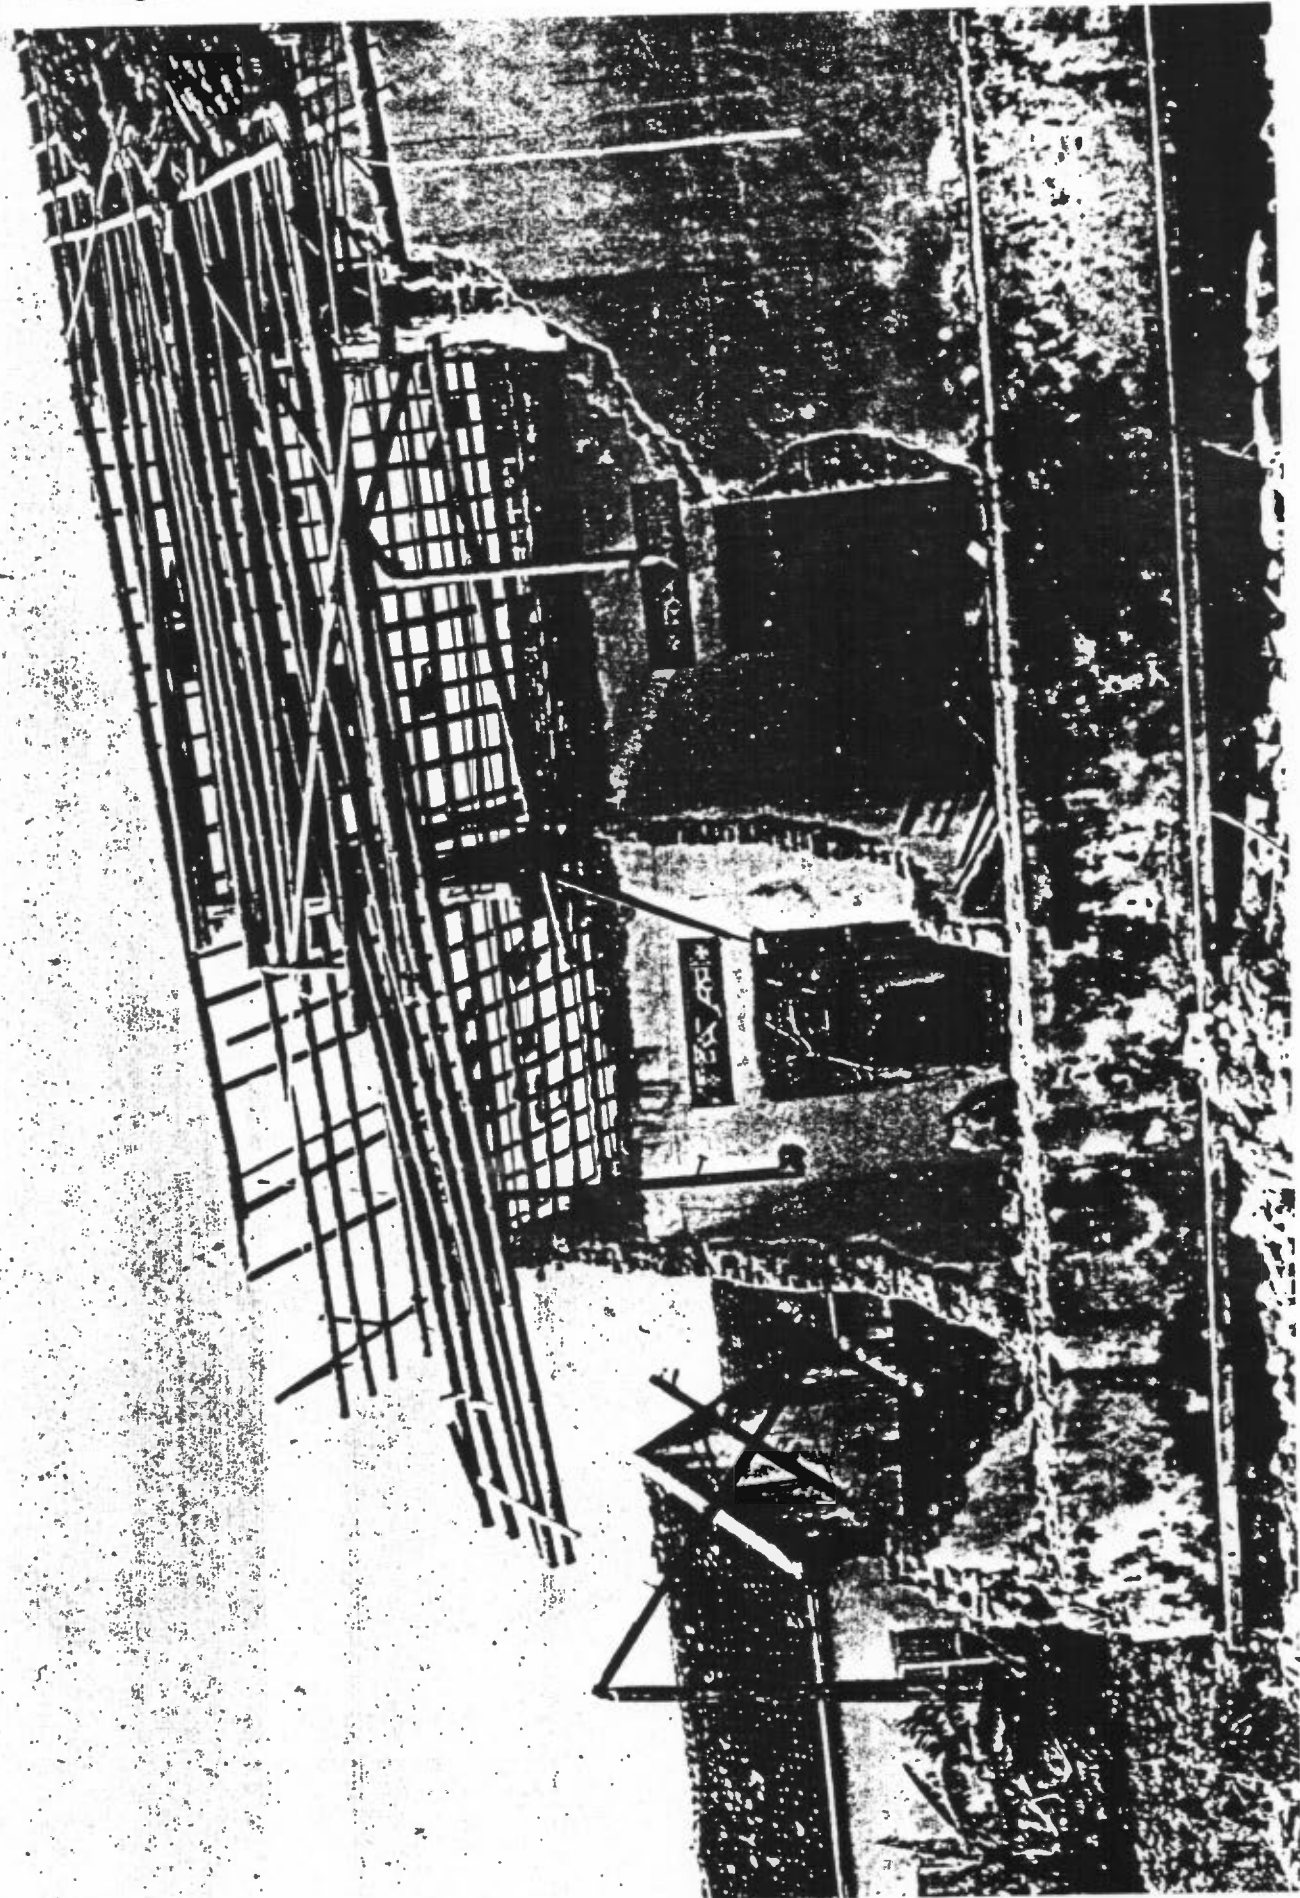
Fig. 15 Damaged building at Quang Xuong Hospital.
